BABBITTED BEARING HEALTH ASSESSMENT

ABSTRACT

This Tutorial will address common bearing failure mechanisms, tools available to diagnose these problems and ways to use that information to make decisions on continued operation. Evaluation consists of analysis of Condition Monitoring information coupled with rotor dynamic analysis and computerized bearing modeling.

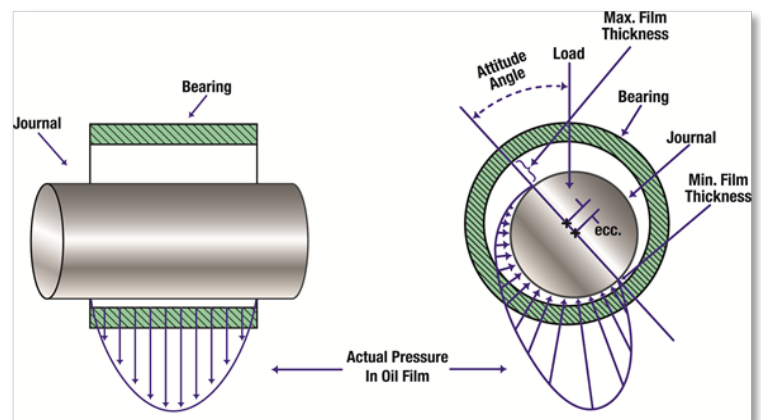
Figure 1 Hydrodynamic film generation

There is a journal rotating (CCW) inside a journal bearing and the rotation of this journal drags oil into a converging space. Since oil is incompressible, all of the oil cannot be pulled through this space so a pressure is generated that forces the oil out the axial ends of the bearing. This pressure is depicted by the pressure profiles as shown.

Figure 1 is a sketch of a journal in a bearing (with greatly exaggerated clearances). This figure also contains some terms that will be used throughout this presentation.

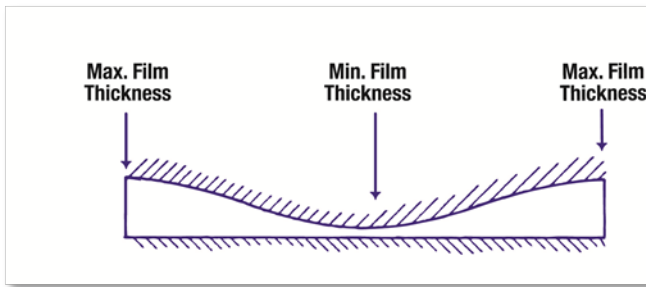
The "*minimum oil film thickness*" lies on the line of centers and can be defined by the eccentricity ratio and bearing radial clearance. Figure 2 is a drawing of the clearance space

unwrapped – starting at the point of maximum oil film thickness (opposite the minimum) and continuing 360 degrees though the minimum and back to the maximum. Here the converging and diverging wedges can be more clearly seen.

Figure 2 Unwrapped Clearance Space

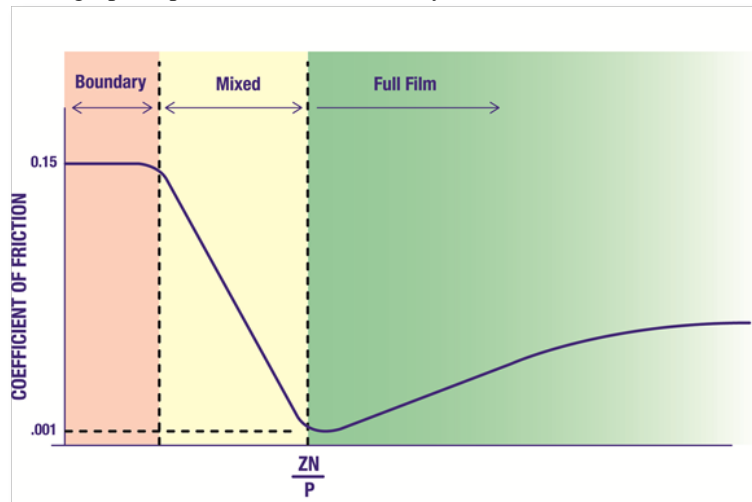
Figure 3 Stribeck curve

At zero speed and at very low speeds there is boundary lubrication; here the two surfaces are in contact with a relatively low coefficient of friction (~0.15) thanks to the presence of oil and two very good surfaces (babbitt and typically a ground journal). Once the speed is sufficient to pull oil into the wedge hydrodynamic pressure begins to develop and the surfaces begin to separate; hence the drop in friction as speed increases, this regime is referred to as mixed film lubrication. Once the surfaces are fully separated we have a minimum friction (depicted as .001 in the figure) and as speed

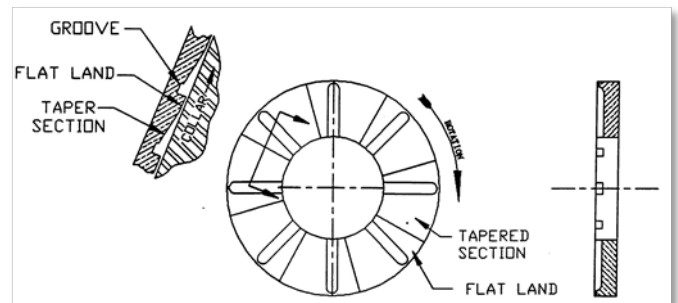
The hydrodynamic principle is the same since the face of the babbitted bearings must have a converging wedge to support the load. Figure 4 contains a drawing of a taper land thrust plate. In this design the wedge (or taper) is machined into the face of the bearing as noted in the section on the left. The rotation of the thrust collar pulls oil into this converging space and hydrodynamic pressure is generated.

Figure 4 Taper Land Thrust Plate

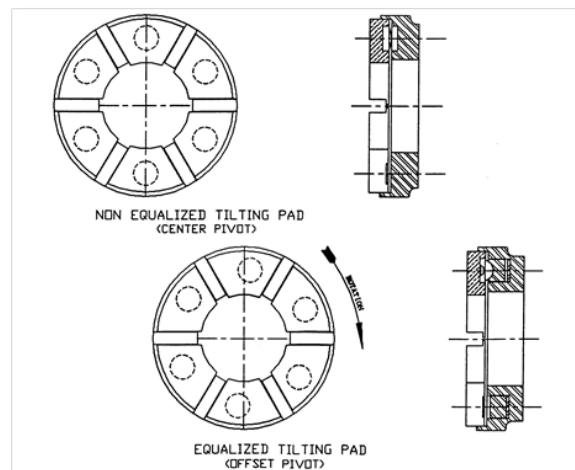
Figure 5 Tilting Pad Thrust Bearings

Figure 5 shows two variations of tilting pad thrust bearings. On top is the non-equalized bearing with pad pivots in the circumferential center of the pad and on the bottom is a fully equalized tilting pad thrust bearing. The equalized bearing

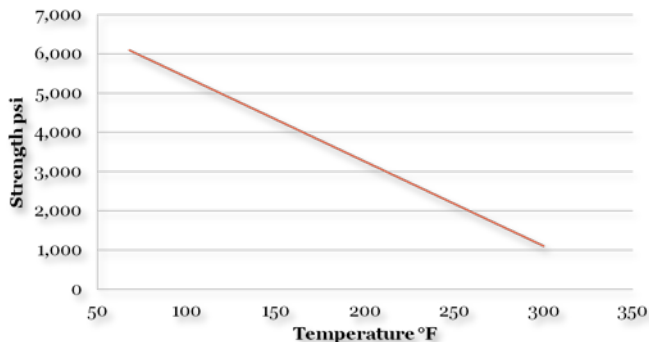
Figure 6 ASTM B23 Alloy 2 Yield Strength

A plot of babbitt yield strength vs. temperature is presented in Figure 6. This data comes from ASTM B23 and has been extrapolated to 300 °F. The yield strength is also presented based upon a 0.125% offset (0.125% deformation of gage length). Yield data is presented at a 0.2% offset from time to time and of course that results in higher values for the yield strength (i.e. 0.125% offset values are more conservative).

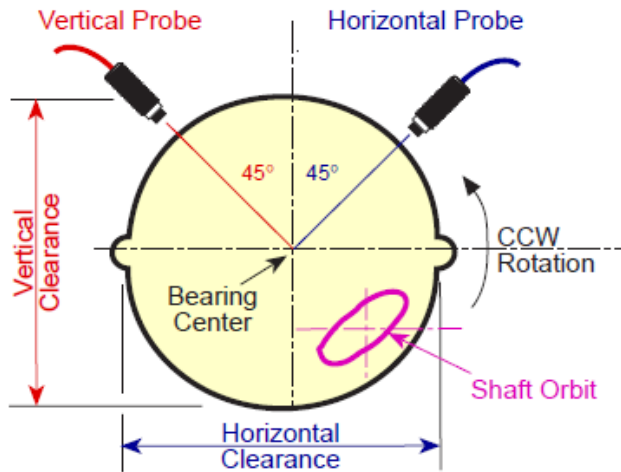
When the shaft begins to rotate, it is lifted by the oil wedge and is displaced laterally in the direction of rotation (see Figure 7). Other influences, such as misalignment and gear tangential and separation forces can also cause movement of the shaft in the bearing clearance.

Figure 7 – Illustration of Proximity Probe Layout and Shaft Movement for a Counterclockwise Rotating Shaft (Eisenmann and Eisenmann, 1997)

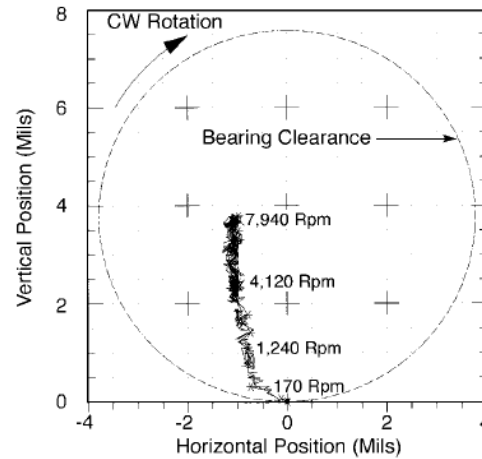
High speed data acquisition systems can record the probe DC components and show changes in shaft position in some detail. Figure 8 is a plot of continuous sampling of DC gap voltages and resultant shaft movement during a start up for a machine with clockwise rotation. The initial point is with the shaft resting on the bottom of the bearing and all the changes in position are relative to that shut down condition. This machine was equipped with tilt pad bearings, and this direction and magnitude change in shaft position is considered normal for this type and size bearing. (Eisenmann and Eisenmann 1997)

Figure 8 – Shaft Position Change during Start Up for a Machine with Clockwise Rotation (Eisenmann and Eisenmann, 1997)

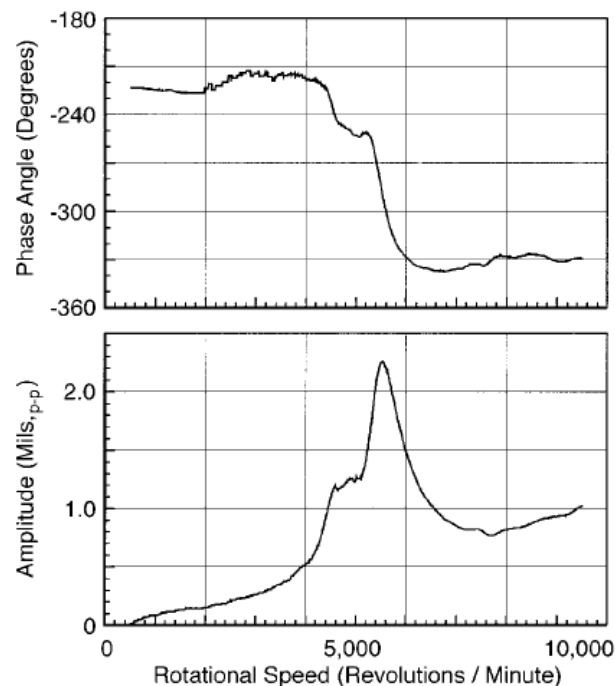
Vibration data acquired during machine start up and shut down (“transient” data) can also be an indicator of radial bearing condition. The Bode plot (see Figure 10) is a representation of synchronous rotational speed (1X) vibration amplitude and phase angle plotted as a function of machine speed. The polar plot (see Figure 11) is the same data presented in a Nyquist format. The Bode plot is helpful in detecting changes with respect to speed, the polar plot shows the change in phase angle and physical orientation in a more easily interpreted format. Cascade plots (see Figure 12) are a data format where spectrum plots acquired at speed intervals during start up or shut down are plotted on the same graph.

Figure 10 – Bode Plot (Eisenmann and Eisenmann, 1997)

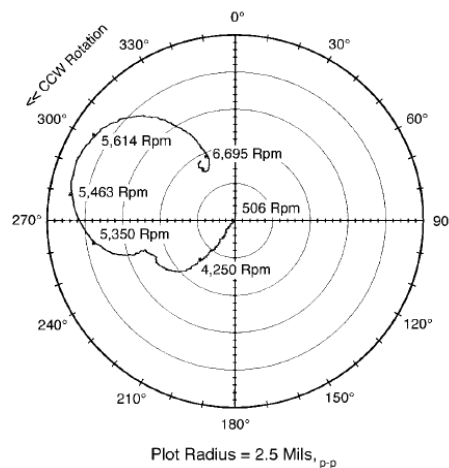
Figure 11 – Polar Plot (Eisenmann and Eisenmann, 1997)

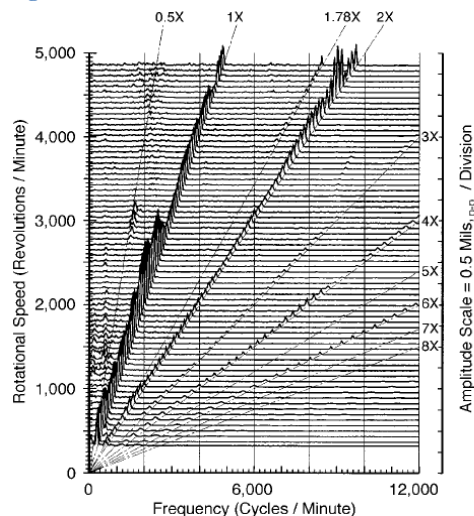
Figure 12 – Cascade Plot (Eisenmann and Eisenmann, 1997)

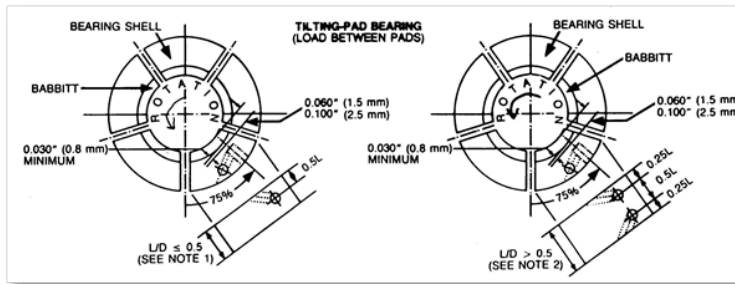
Figure 13 API 670 Figure for TPJ Instrumentation

Proper thermocouple or RTD placement in a 5 pad tilting pad journal bearing oriented in a load between pad (LBP) configuration is denoted in Figure 13. Note the instrument is located very close to the babbitt bond line and 75% in circumferentially from the pad leading edge. The 75% location may not represent the hottest portion of the pad surface but it does closely represent the most distressed location taking into consideration temperature and film pressure. Also note the instrument should not compromise the bond line as dimpling of the babbitt surface is possible.

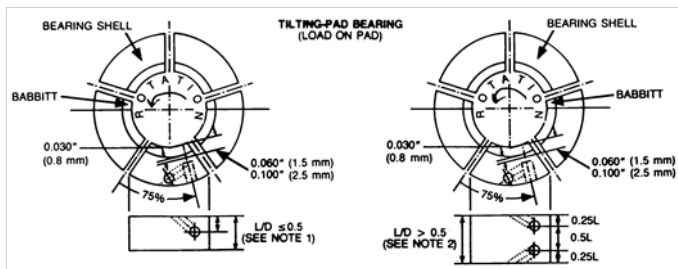
Figure 14 API 670 figure for LOP instrumentation

Figure 14 is for Load on Pad (LOP) configurations. There is also a similar figure for sleeve bearings. Figure 15, also from API 670, denotes the proper location of temperature instrumentation in tilting pad thrust bearings.

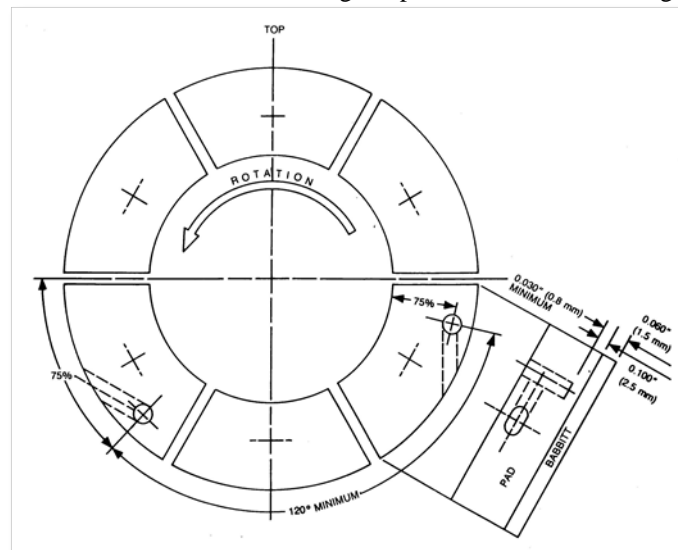
Figure 15 Temperature sensor placement in thrust bearings

Note that these are very good standard locations for sensor placement. They closely represent the most distressed location in the bearing and the standardization allows one to effectively analyze the condition of the bearing. For instance if there was a sensor placed at the center of the pad there would need to be some of correlation required to estimate the temperature at the API location.

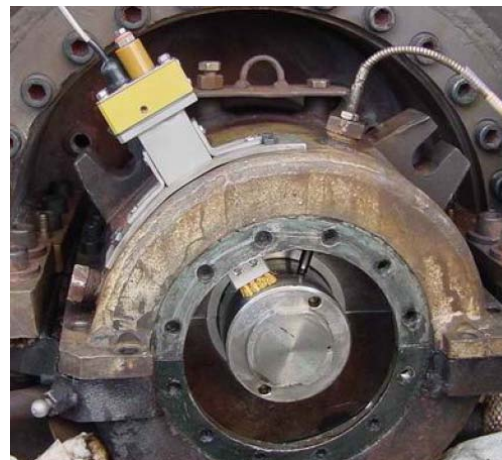
Shaft grounding brushes serve two purposes. The brushes are able to transmit modest amounts of stray current to ground for prevention of arc damage through parts of the machine (especially the bearings). The brushes also permit measurement of the shaft voltage and current, which allows assessment of the electromagnetic condition of the machine.

Figure 16- Typical Grounding Brush Installation (Sohre, 2010)

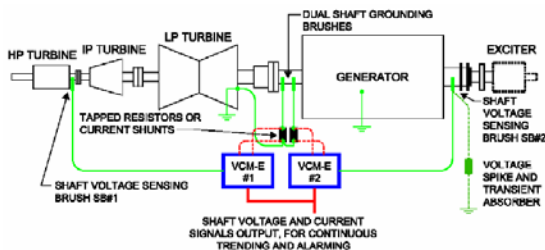
Monitoring to determine shaft current level and changes is performed using a shaft voltage current monitor (VCM). The VCM measures voltage and current through the grounding brushes. Ideally, the output of the VCM should be connected to a recording device or plant data historian so that trends of the voltage and current can be used to detect changes in shaft electrical properties. If readings increase slowly, it could be an indication of deterioration of the electrical machinery (motor, generator, or exciter) or possible progressive self-magnetization of the machine. Sudden increases in current may indicate that self-magnetization has occurred, possibly due to the reasons previously mentioned.

Figure 17 – Shaft Voltage Current Monitor Installation on a Turbine Generator (Nippes and Galano)

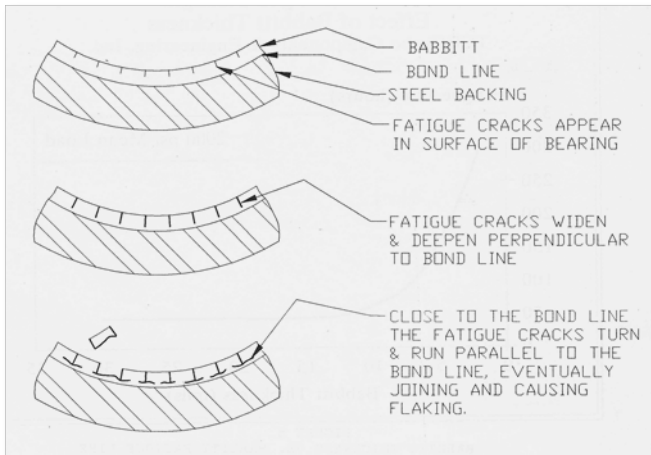
circumferentially, meeting with other cracks and dislodging pieces of babbitt. This is conceptually illustrated in Figure 19.

Figure 19 Fatigue crack propagation

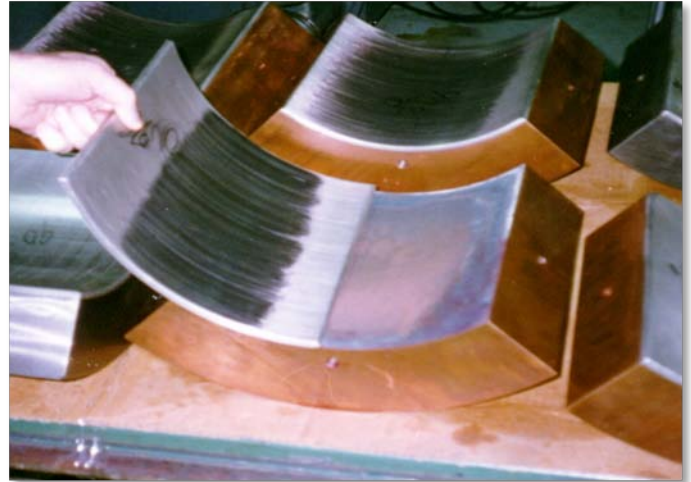
This is most common when babbitt is applied to copper alloy. Copper is used extensively to reduce bearing operating temperatures by allowing a significantly increased heat transfer coefficient. Most bearing companies use a copper alloy that has good stiffness and strength while still having good heat transfer properties. Figure 23 is a photograph of a sheet of babbitt that came off of a 16" journal pad.

Figure 23 Loss of bond with copper pads

It has been discovered that copper has a strong affinity for tin and this is magnified at elevated temperatures. When babbitt is applied to bearings the process includes a tinning operation so the tin adheres to the base metal and then the babbitt bonds to the tin. Should the tin diffuse into the copper the bond will become weaker and weaker, and brittle. Oddly enough this is often times not discovered during normal NDT inspection (such as visual, PT or UT) since the bond is intact, it is just compromised and measures of bond strength are destructive.

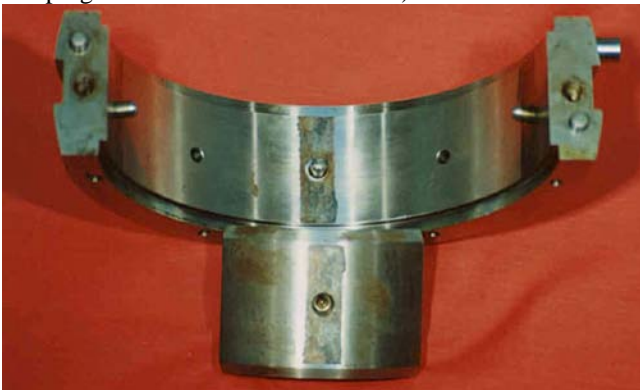
One way to detect the possibility of this happening is by monitoring the shaft centerline position for journal bearings and axial position for thrust. If moves are detected and there is no tin found in the oil then one may conclude there is a possibility of pivot wear. For journal bearings this could also be accompanied with increased vibration (due to loss of stiffness and damping with the increased clearance).

Figure 25 Pivot wear

This damage can be avoided with a lower stress pivot design and/or control of vibration levels.

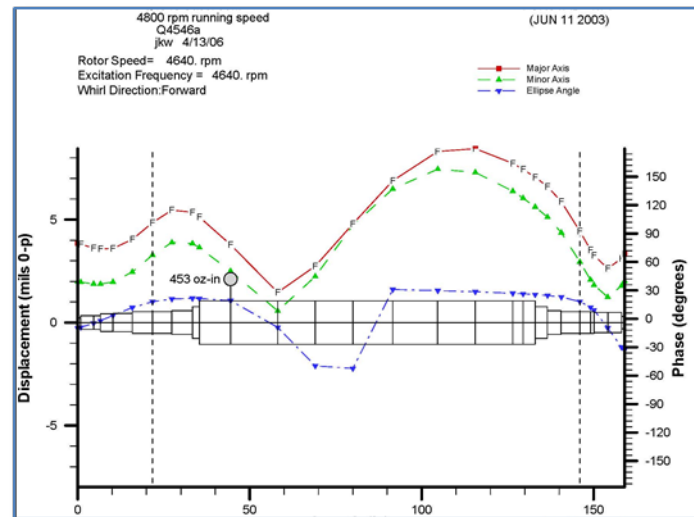
Figure 29 Rotor deflection due to imbalance

The rotor model the rotor deflection shape from an unbalance at the first wheel are presented in Figure 29. Note that this is a drive through machine so there is a coupling on each end. Also note that the analysis predicts that for this unbalance the vibration at each bearing should be about the

same. However the actual machine had 5 mils vibration on one bearing and 1 mil on the other. It was determined that an unbalance between bearings could not duplicate the vibration spread observed.

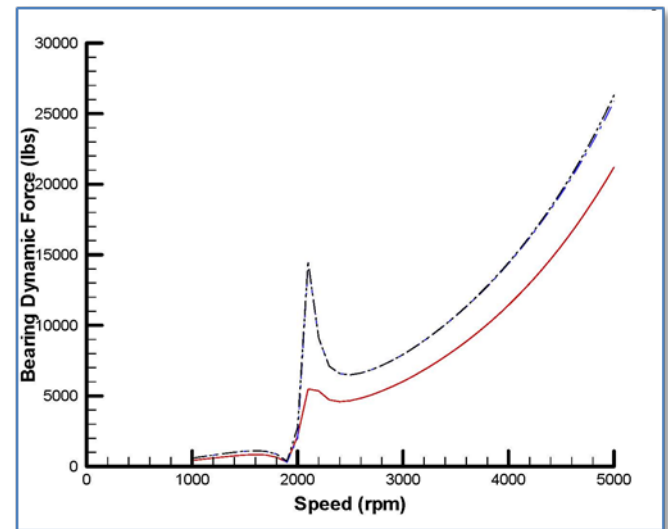
Figure 31 Bearing force due to coupling unbalance

The dynamic force imparted on the bearing due to a coupling unbalance sufficient to raise the vibration to 5 mils is depicted in Figure 31. Note the significant dynamic load (which is zero to peak). The bearing had (roughly) a static load (journal

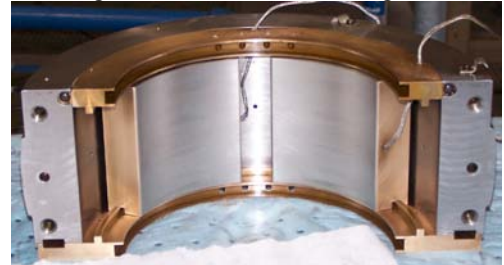
In total 8 turbines and compressors were retrofitted with more robust TPJ's and one journal bearing in the gas turbine was upgraded from a sleeve bearing to a TPJ. Most of these bearings have gone through 2 outages now; one at 4 years, one at 5 and the plan is to now run 6 years. Of the 17 journal bearings upgraded the worse of them had an increase in clearance of 0.6 mils and all the rest opened up less than 0.5 mils. So after 9 years of operation they cleaned up, checked and reinstalled all 17 bearings. The figures below represent what a few of these bearings looked like after cleaning.

Figure 37 201 compressor after 9 years operation

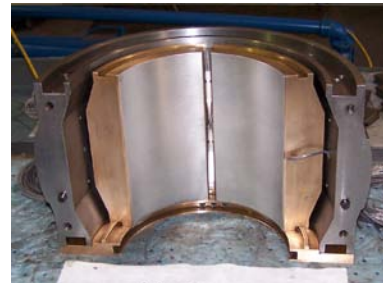
Figure 28 601 bearing after 9 years in operation

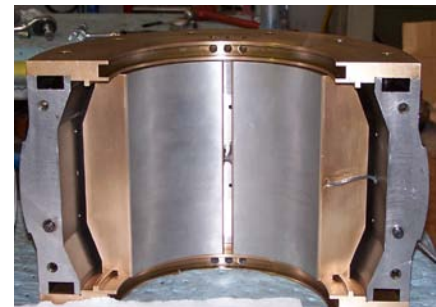
Figure 39 201A Bearing after 9 years in service
